The Condition of Unsealed Roads in Slaley Forest

A Report by the Byways & Bridleways Trust

This report is based on observations and photographs taken on Sunday 18 March 2007. Present were: Norman Canham, Alan Kind & Ken Lord. The weather was a mix of sunshine and heavy sleet showers,

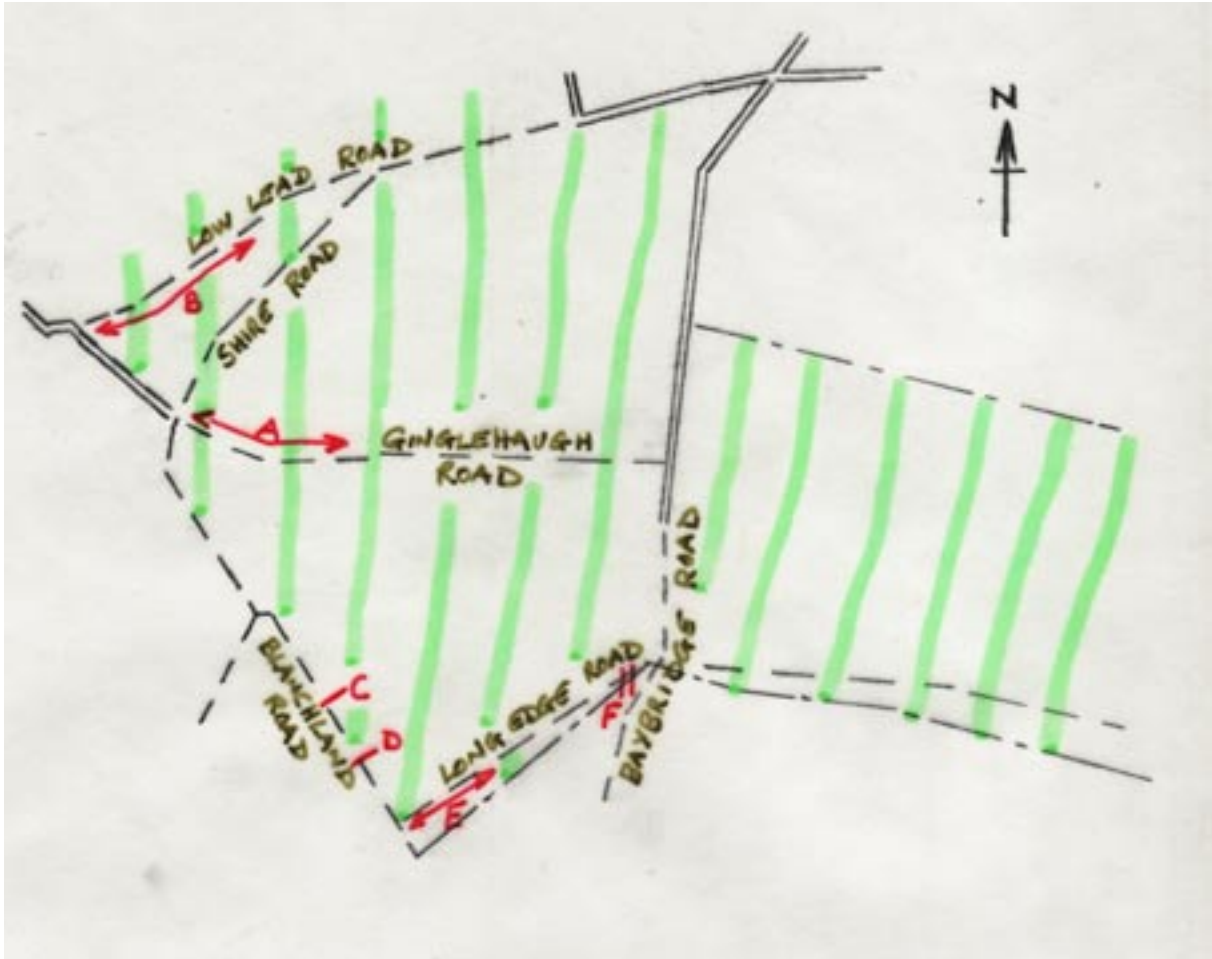
following a lengthy period of sustained rainfall. This sketch map indicates the various unsealed roads to the west of Baybridge Road, and uses red marks to identify problem points.

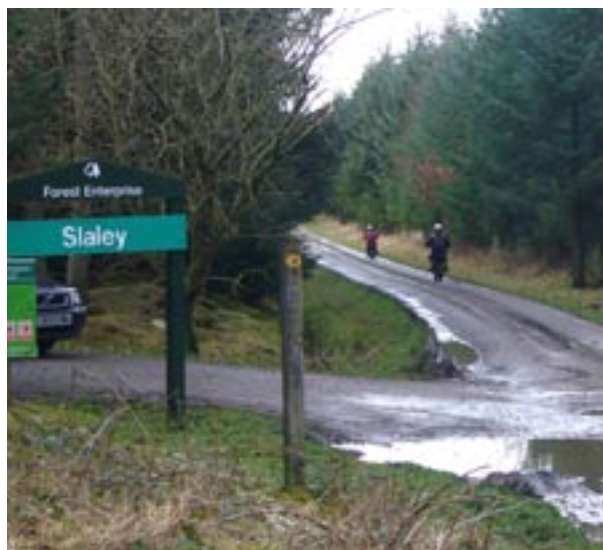
I then drove over the brow of the hill (southwards) to where KL & NC were parked. As we put our gear on a group of four vehicles came past, heading south: a trail bike with a numberplate, a long-distance-trials-type sidecar outfit – again apparently legal, with two large-capacity ‘race’ quads, one with a number plate, and one without. We later observed the sidecar’s tyre pattern (a narrow rib) on the worst part of GR, so it is reasonable to believe that this group came up GR from the west.

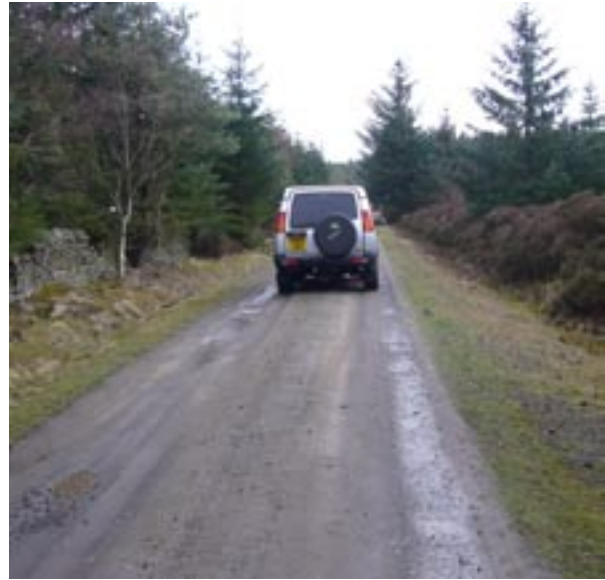
We walked west along the 'forest road' section of GR. We met a 4x4 coming towards us, apparently out of the forest's central area – i.e. not the bad section of GR – and this was being driven by a boy clearly well under licence age.

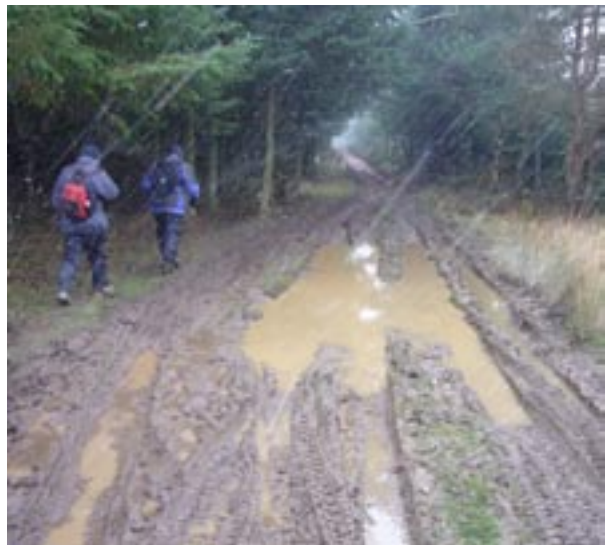
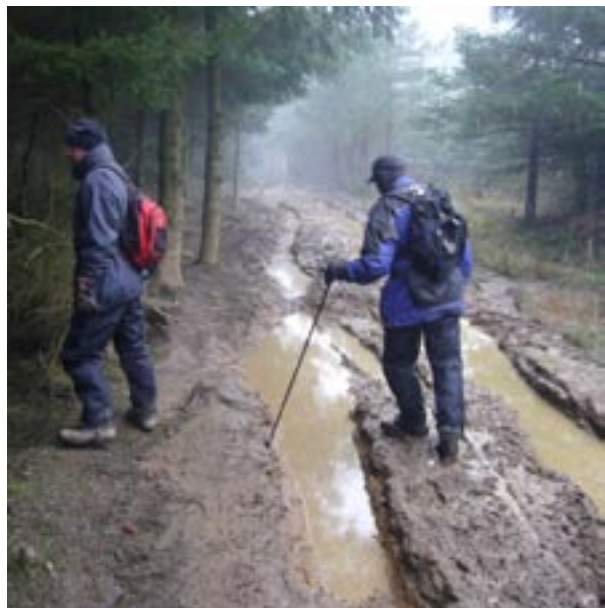
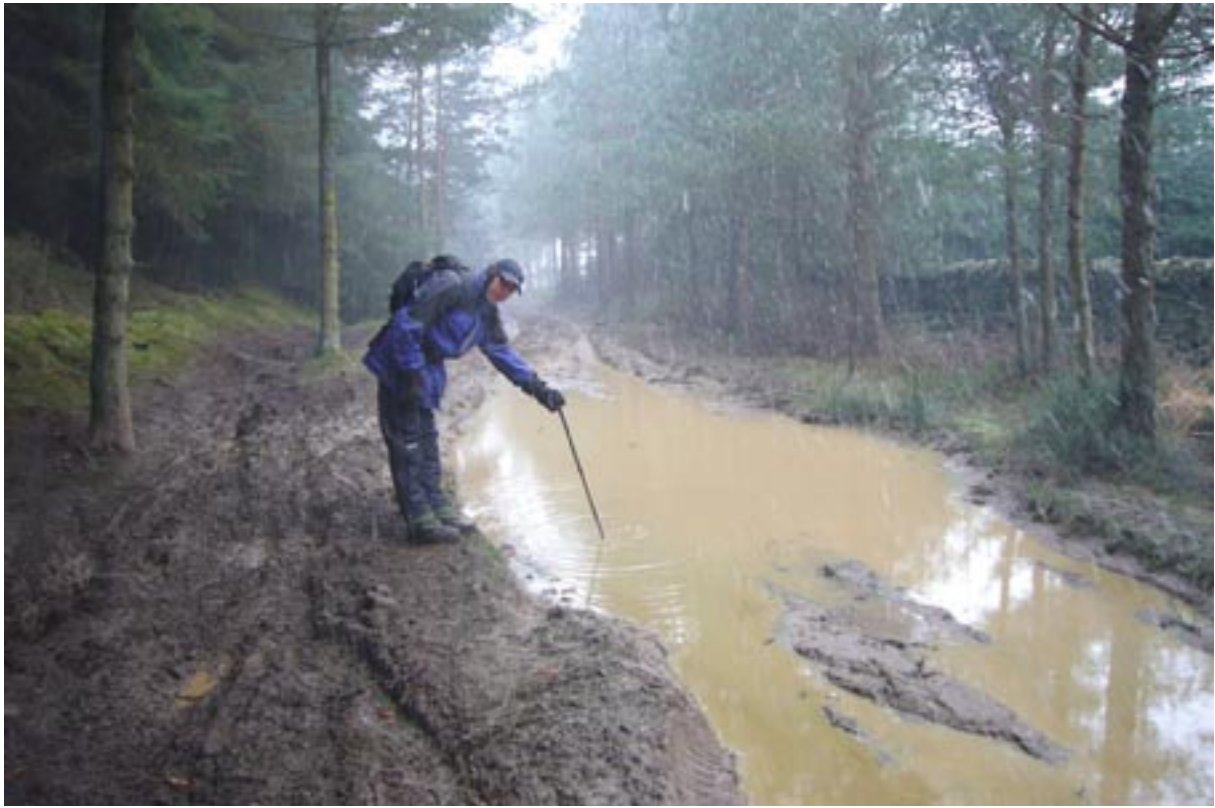
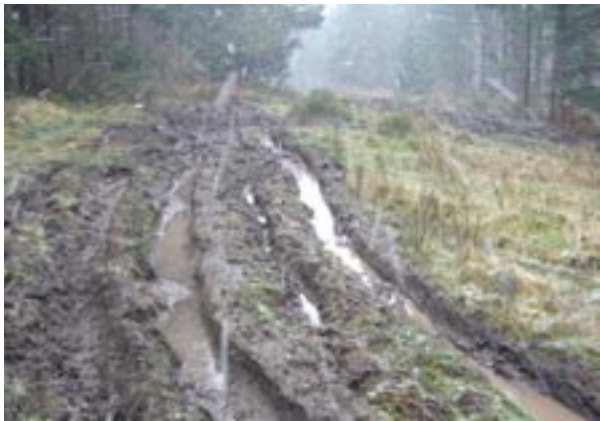
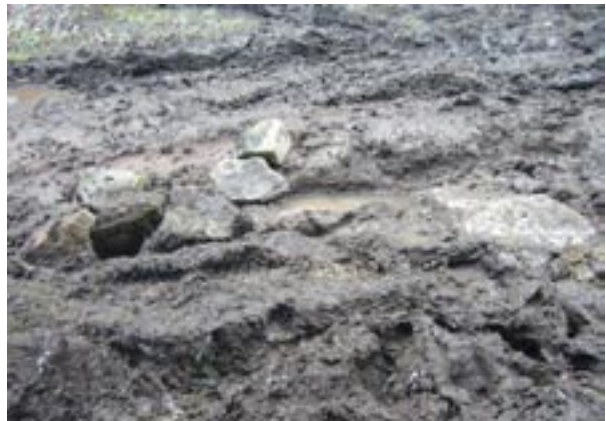
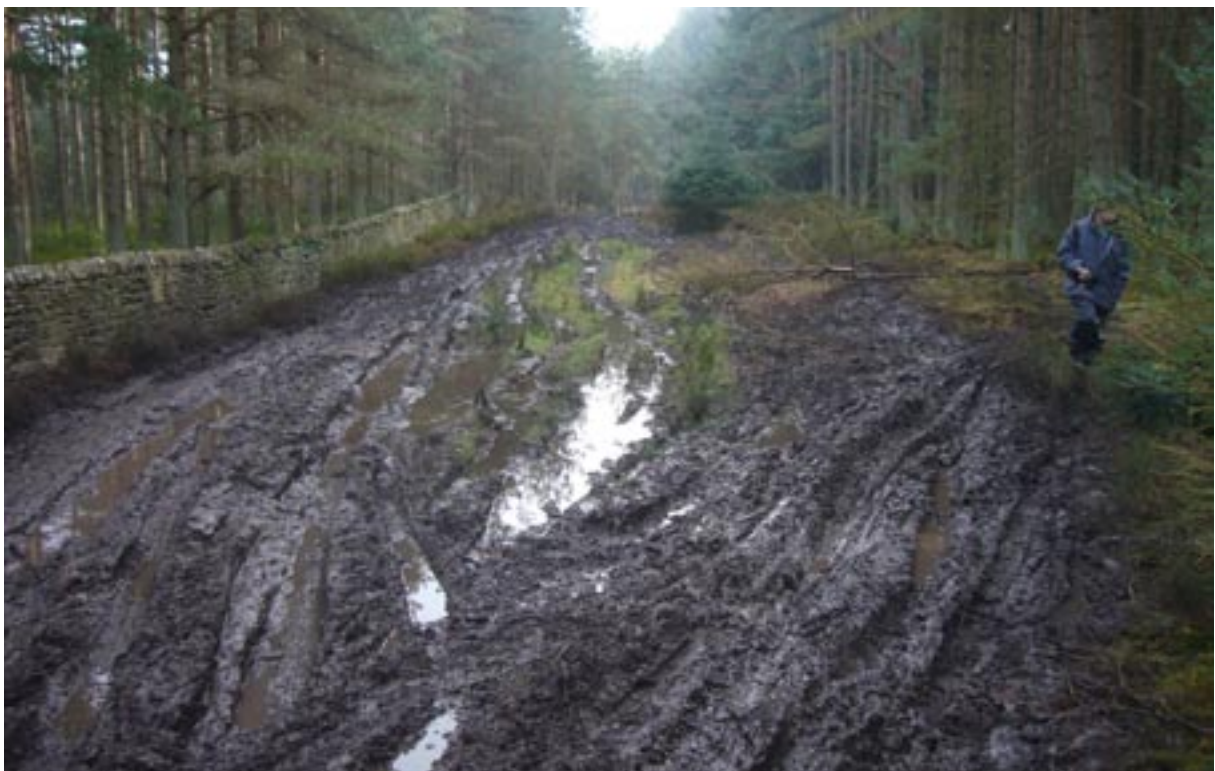
The current condition is very bad for most of the downhill (going west) stretch, as far as the junction with The Shire Road. It is clear from the wheel marks that 4x4 vehicles have had a major impact on the 'clear' central strip, with motor cycles going ever-wider in an attempt to get around. There are also places where it is clear that motor cycles are going into the central forest. The tracks suggest that this is not in seeking a 'bypass', but in using the forest as a riding area.

As of 18 March 2007, the condition of stretch 'A' is appalling. It is difficult to walk, and effectively impassable for pedal cycles, horses, and motors with 'reasonable' tyres. Years of experience suggests that it will dry out, but without some work would remain rutted.

Past investigations suggest that this stretch has been roughly metalled (stoned) at some time, but that there is centuries of detritus on the top now.

Stretch 'A' on Ginglehaugh Road needs some basic drainage work, and proper exposure to sun and wind. It might also need a permanent management regime limiting some types of use after wet weather (as, for example, the 'reactive TRO' on Ermine Street, Goose Green, Hertfordshire). With the nature of the illegal use in the area, voluntary restraint alone will not deliver.

1. Put a temporary traffic regulation order on the bad part of Ginglehaugh Road immediately.
2. Northumberland County Council should work with Northumbria Police to crack down on the continuing and very visible level of illegal motorcycling in Slaley Forest – but the primary responsibility here rests with the police.
3. Initiate a 'Forest-wide Management Plan' involving all the main parties. This Plan to concentrate on restoring a sustainable balance of use by basic repair (sun & wind, drainage, and a bit of selective fill) coupled with appropriate regulation where necessary
4. Continue monitoring and adapt the policies adopted accordingly.

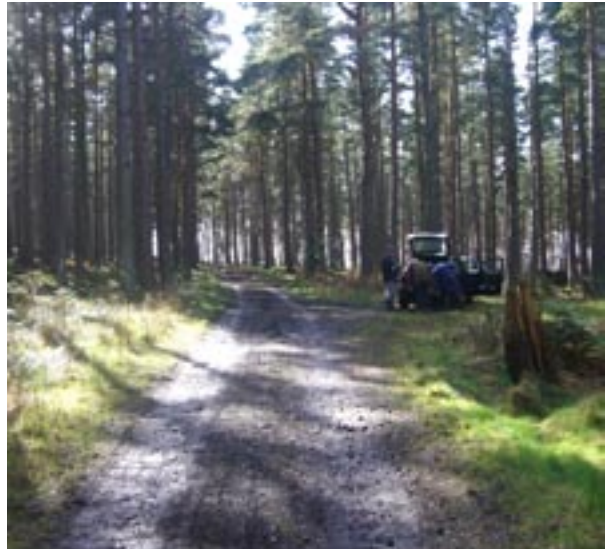
We turned north off Ginglehaugh Road, on to The Shire Road. The condition of this is excellent – witnessed by this carload of walkers, which had driven down half a mile or so from the junction with the blacktopped road to Whitley Chapel. We continued on to the acute ‘Y’ junction with the Low Lead Road, where we turned back towards the west. The condition here is poor due to overgrowth and fallen trees (example in photograph).

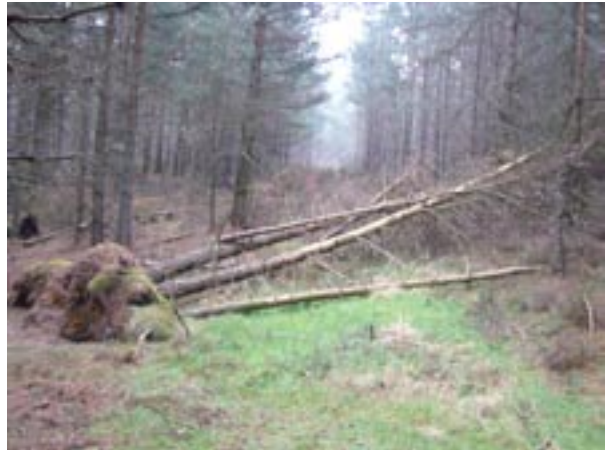
Further along the LLR, at stretch ‘B’ on the sketch map, there are two patches of very soft ground with some motorcycle wheel tracks clearly visible. Both areas are where water is streaming across the road. At the first (northerly) place there is a footbridge and a rudimentary ford – clearly this is normally wet to a degree.

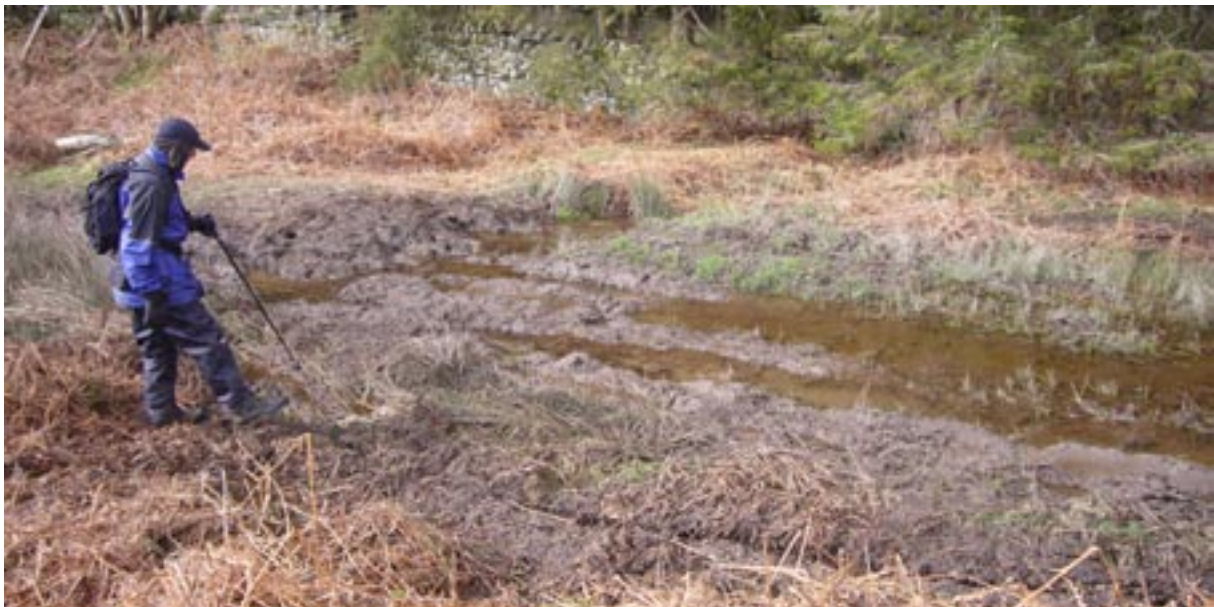
At the other place (in the photograph below), quite close to the junction with GR, there is a long wet slough, with water visibly pouring in from the slightly higher wooded area. The hollowway of the track is simply forming a sump for surface drainage.

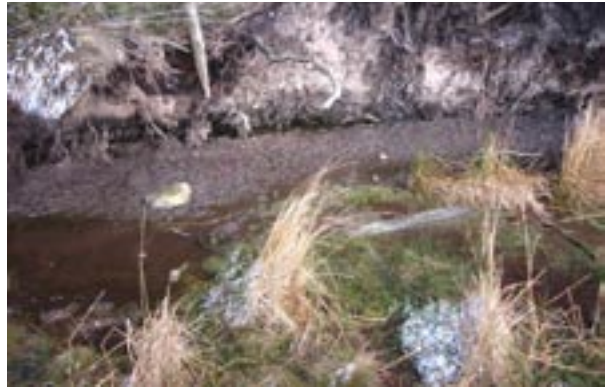
We next walked back (east) up GR, then turned right (south) along The Shire Road, which hugs the edge of the forest. We kept to the edge of the forest, leaving TSR and continuing along Blanchland Road. We found two wet areas at points 'C' and 'D' on the sketch map. At one, adjacent to a big windblown tree with an exposed root, the water was streaming on to the road (and fell) from inside the forest at a colossal rate. It was running in rivulets into, down, and through the worn track. There were tyre marks clearly visible here, but the ground was a soft bog even where tyres had not passed.

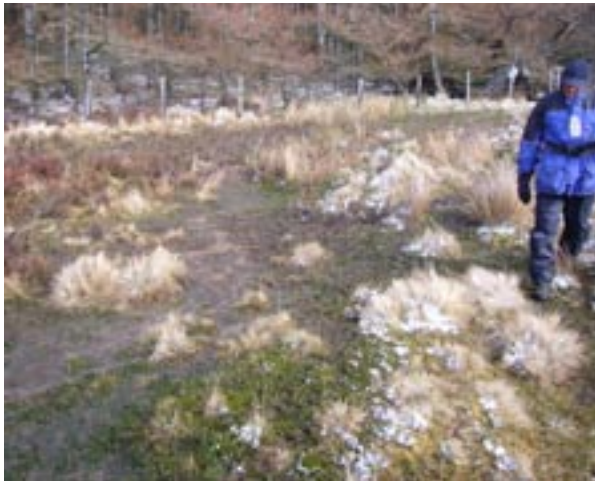
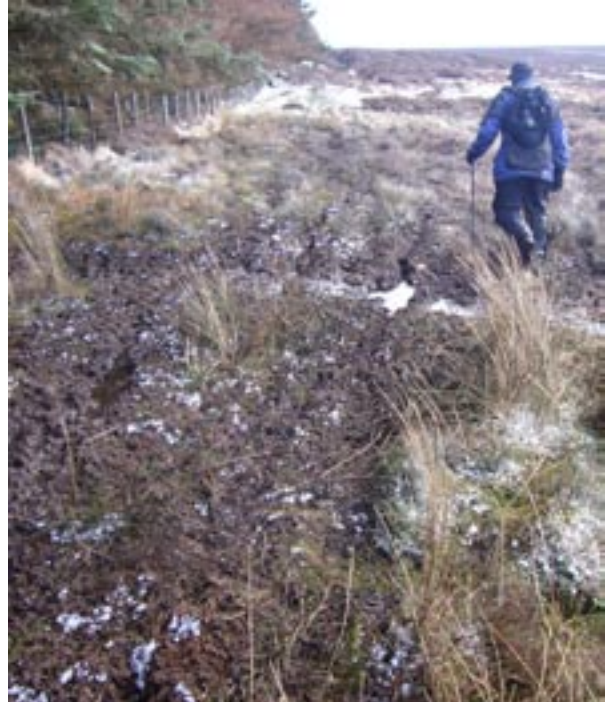
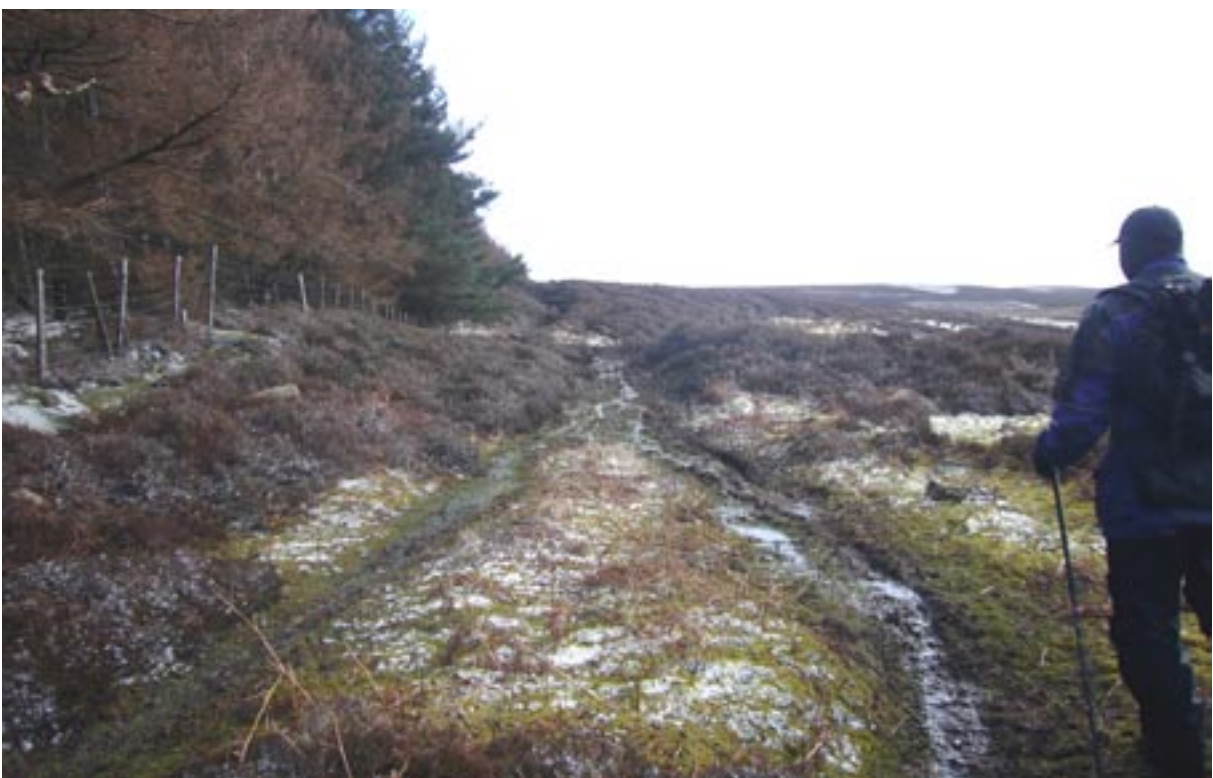
Historically, this stretch has been kept passable for cycles and horses by the passage of (sufficient) trail bikes. There has been the occasional mark, but nothing that does not dry out readily. If this use did not happen, the voracious heather hereabouts would soon choke the road completely.

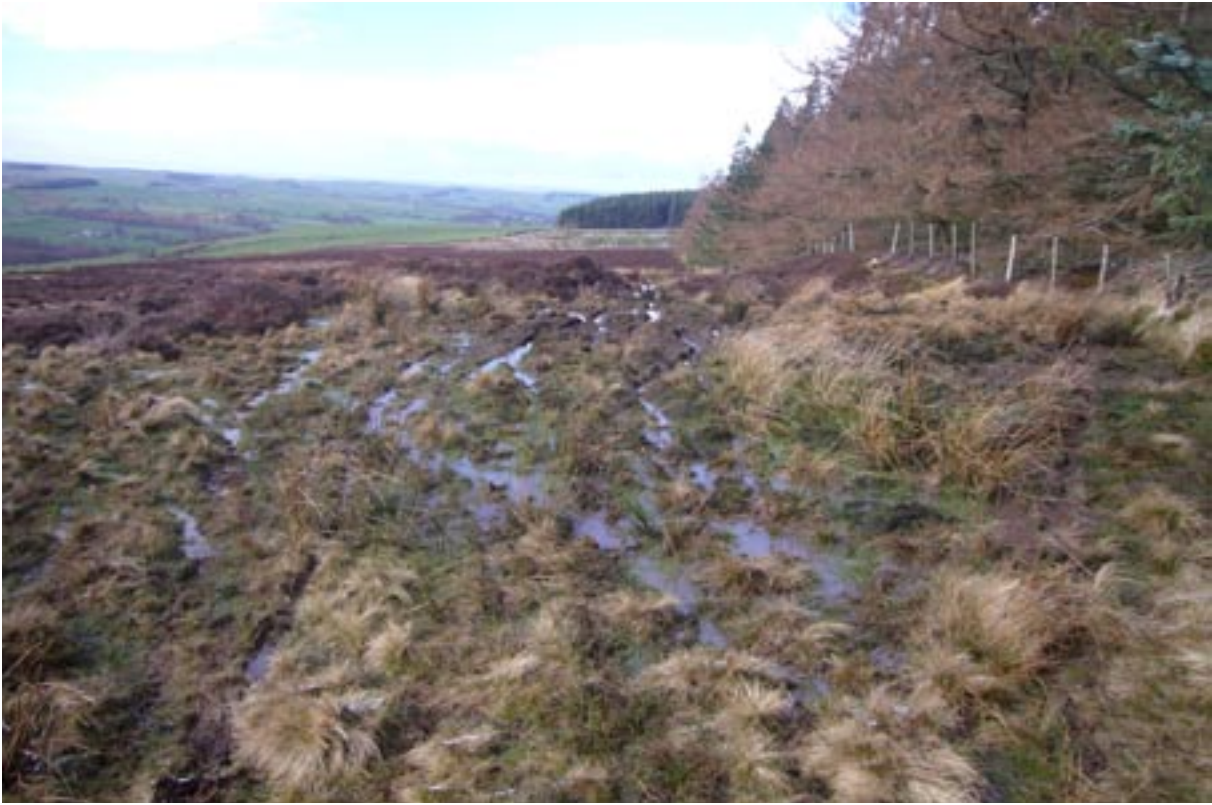
We next arrived at the field gate at the west edge of stretch 'E' on the sketch map. This is about 30 yards north of where Long Edge Road actually enters the forest from Blanchland Road (GR 944541), but by agreement with Forest Enterprise, this is where the

public has entered the forest, until the line of LER is reinstated and made usable. There is a footpath running straight ahead from the camera (on the gate top), and plainly logging operations have adversely impacted this.

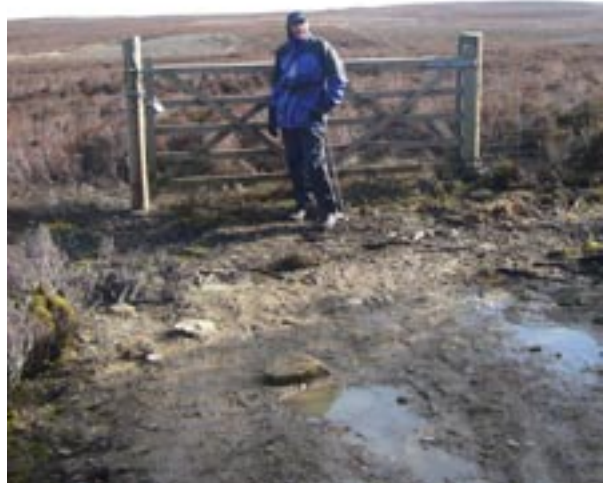
Where Long Edge Road approaches Baybridge Road, FE has put in a new length of causewayed road, leading to a (locked) gate on to the fell at around GR 953546. This looks to be intended to provide the proper alignment of LER, which leaves the forest for a short distance, before dog-leg crossing Baybridge Road. This gate appears to be in the wrong place – too far east.
