The Condition of 'The Racecourse Road'

A Report by the Byways & Bridleways Trust

'The Racecourse Road' is the name given by users to the through-route formed by Bridleway 12, Hexham Town, and Footpath 13, Hexhamshire Low Quarter. This report is based on observations and photographs taken on Friday 20 April 2007. Present were: Norman

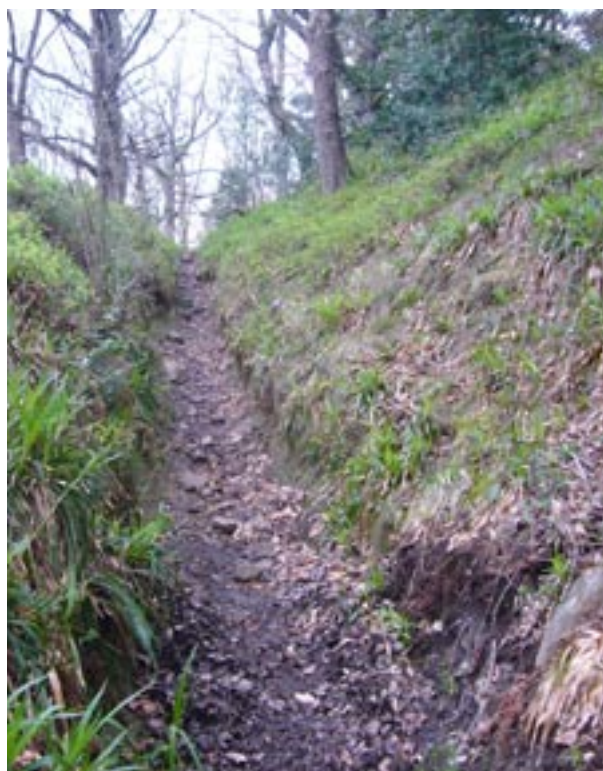
The condition has changed significantly in one stretch, marked as point 'A'. This is a steep descent (going southwards) and has been eroded by water-flow into a deep and narrow holloway for around 100 yards. This is not caused by vehicles – there were no marks, or tracks, and the relatively regular profile of the holloway indicates the smoothing effect of water. This erosion is now significantly worse than five or ten years ago. There is no sign of repairs, nor of any works to divert flooding surface water.

The photograph to the right is looking uphill (northwards) at point 'A'.

The downhill section in the woods is badly eroded by passage of surface water, not by the trail bikes (and other traffic) that already use the road. This section is already out of repair for non-motor traffic. The need here is for some diversionary drainage work and refill. These works would obviate most of any perceived future 'dangers'.

This route is, for most of its length, no better or worse than most other unsealed ancient highways in the area. It has one stretch (point 'A' on the map) that has become badly water-eroded to the point where it constrains all traffic into the holloway. This must be repaired anyway – BOAT status or no – and, once done, use of the route by motor cycles is not likely to be excessive, nor inherently dangerous to other users. The Trust exhorts Northumberland County Council to engage all interested parties to draft a simple management plan to effect repairs and consider what levels of traffic management and regulation need to be applied in order to achieve sustainable use of the route by as many types of reasonable user as circumstances allow.

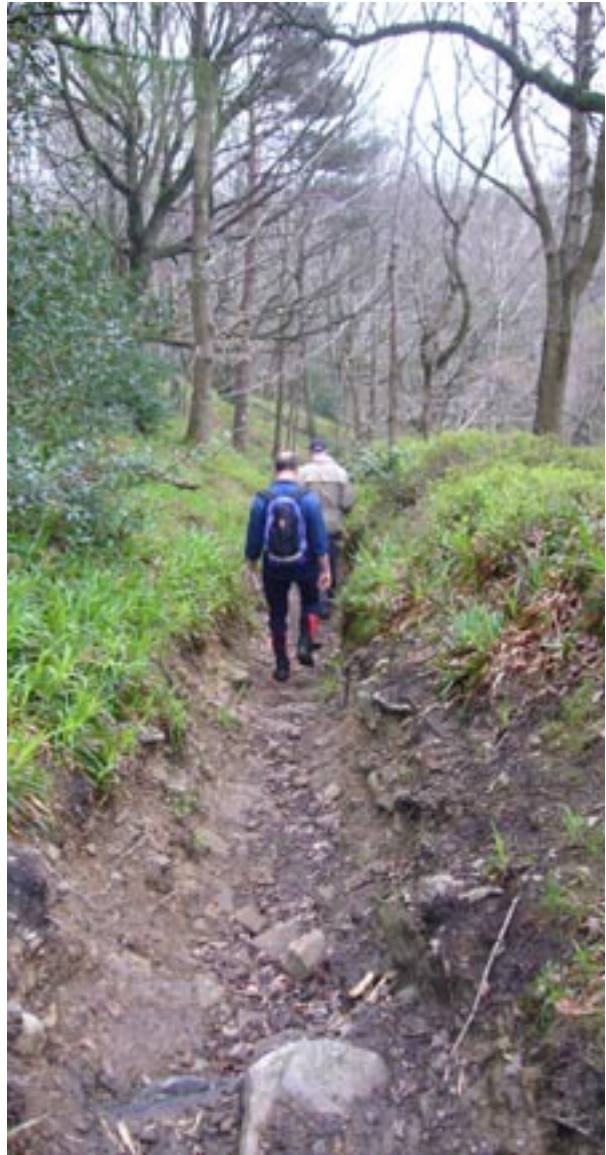
The photograph to the right is above point 'A', looking downhill (south). There were the marks of one horse on the climb. Pedal cycles could descend this (it would take a very fit and skilled cyclist to climb it) but could not meet and pass walkers or riders without someone climbing out of the holloway on to the banks.

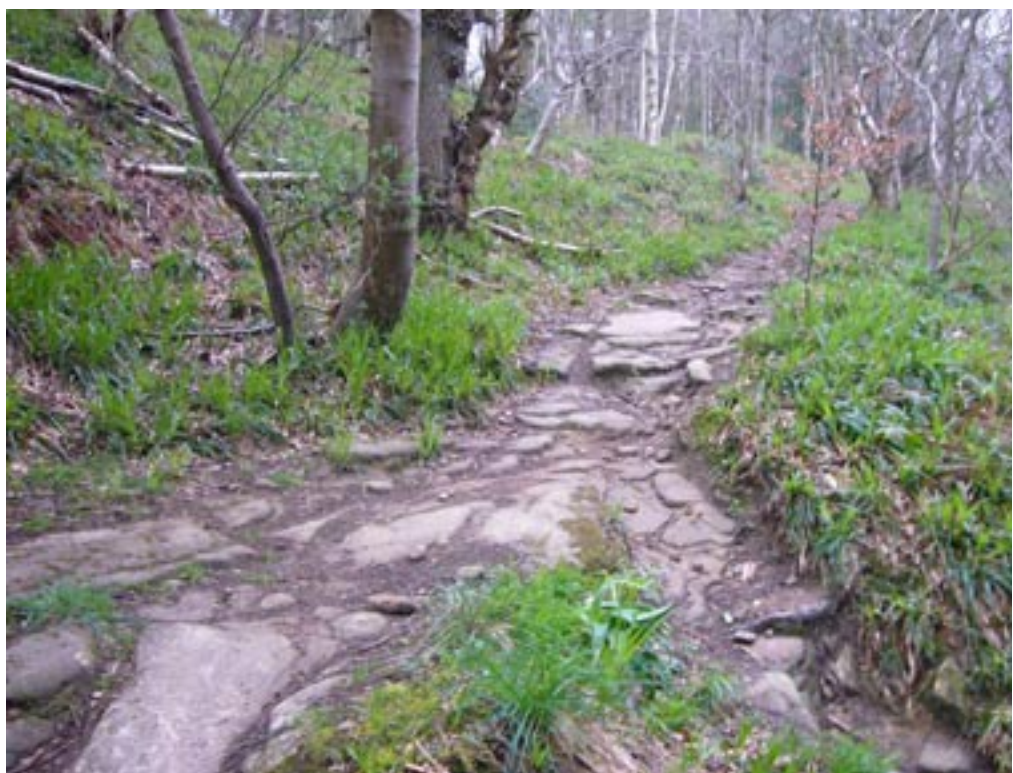
The photograph below is part of the zig-zag at the foot of section 'A'. The route here is bedrock, and apart from the smoothing of centuries of traffic, there is no sign at all of user impact.

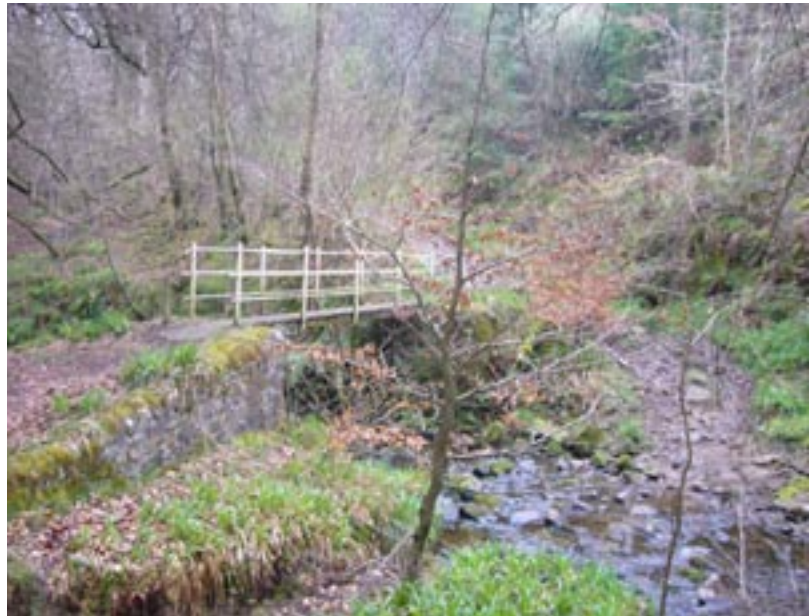
Top right: The ford at point 'B', looking south. This is a properly engineered vehicular ford, so presumably the traffic using it came from, or continued to, the north? The footbridge also suggests significant pedestrian use of the road at some time. The bridge handrail is badly loose and this could result in serious injury.

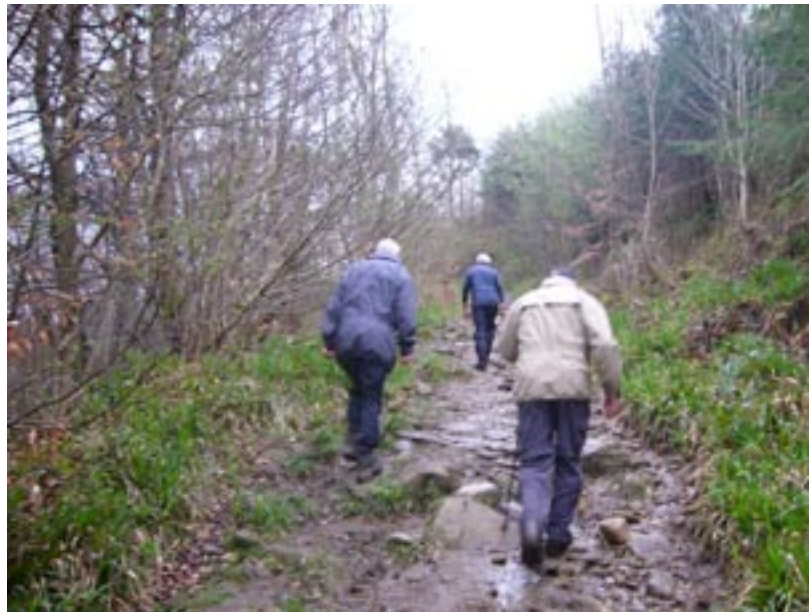
Centre right: Climbing up the steep bank at point 'C', southwards. This section is also at least part bed-rock. It needs a small amount of remedial work, and some attention to drainage.

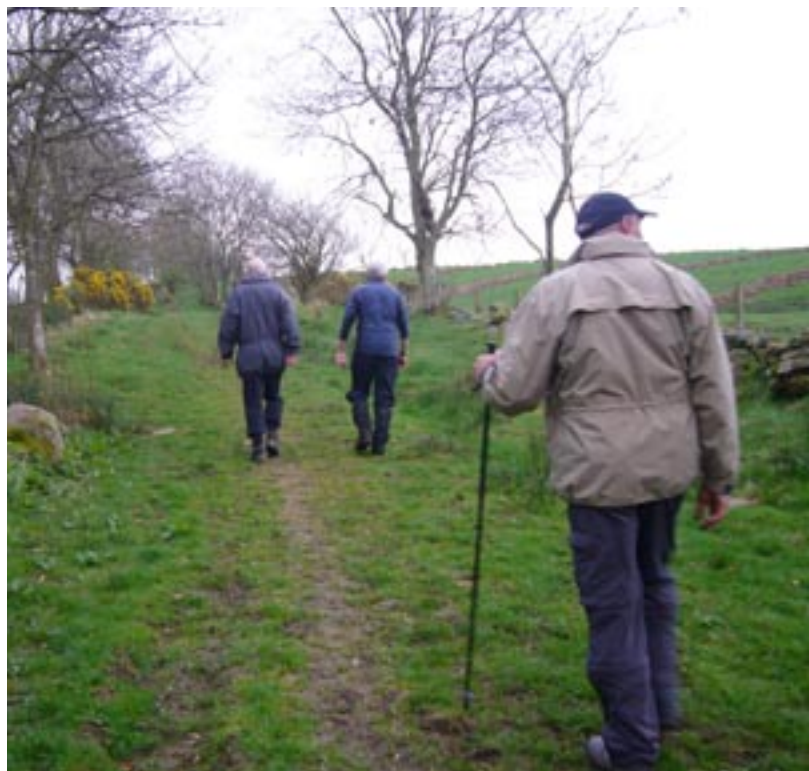
Bottom right: Walking southwards at point 'D'. This section is a classic walled, grass-on-stone lane. It can plainly carry its traffic without undue impact.
